1 Port Street - Coastal and Marine Assessment Information Sheet

Shoreplan Engineering Limited was retained by Canada Lands Company to review and assess conditions of the coastal structures.

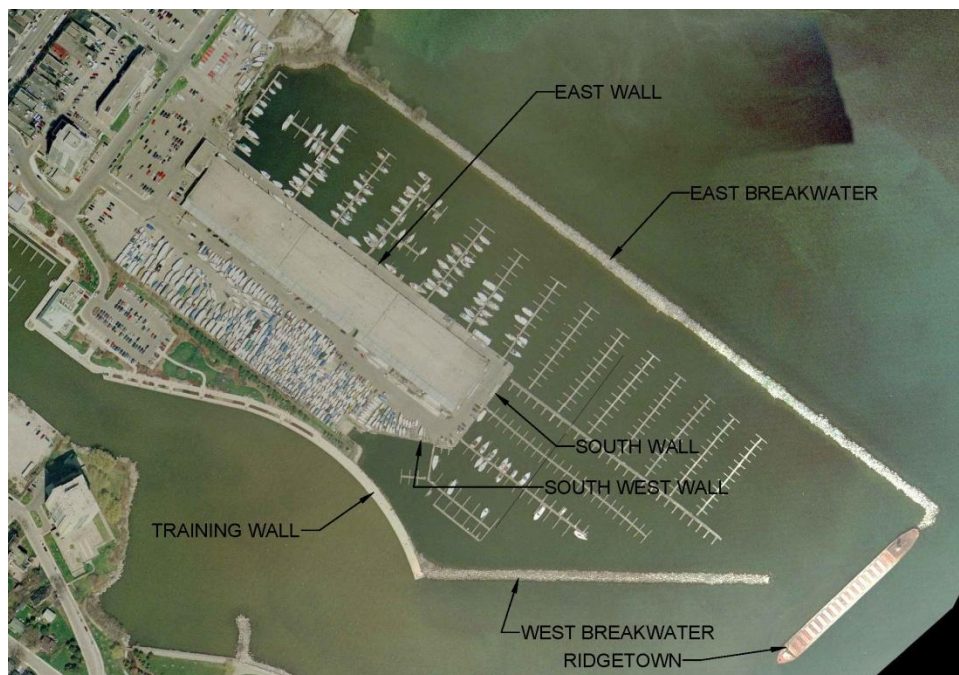
- The site contains a number of marine structures that were constructed between 1958 and 1975. They include the east and west breakwaters, a decommissioned ship called the “Ridgetown” that acts as the south breakwater, east, south and southwest wharf walls and the curved training wall.
